# Case 4: Dawson Creek Empty Lot, Canada

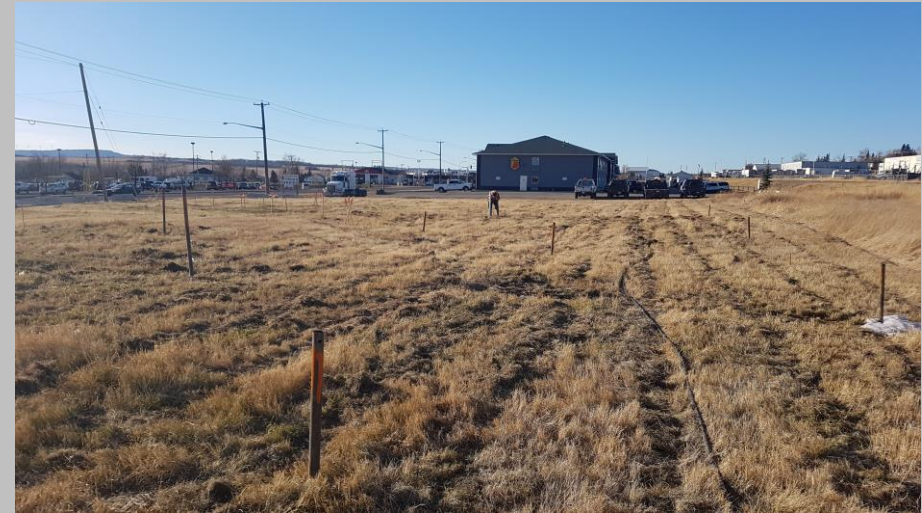
- This site is a commercial property located in Dawson Creek, BC which was contaminated with hydrocarbons during historical railroad operations at the site.
- **Solution:**
- The site was bioremediated using a combination of electrokinetics, biosurfactants, and hydrocarbon degrading bacteria and fungi. **EKOGRID™** was used for delivery of remediation reagents and for remediation.
- **Results:**
- The site was treated for 30 days under winter conditions and a significant reduction in hydrocarbons occurred, allowing for the successful risk assessment of the residual impacts.
