Case 8: VICTORIA BIO-PILE, CANADA

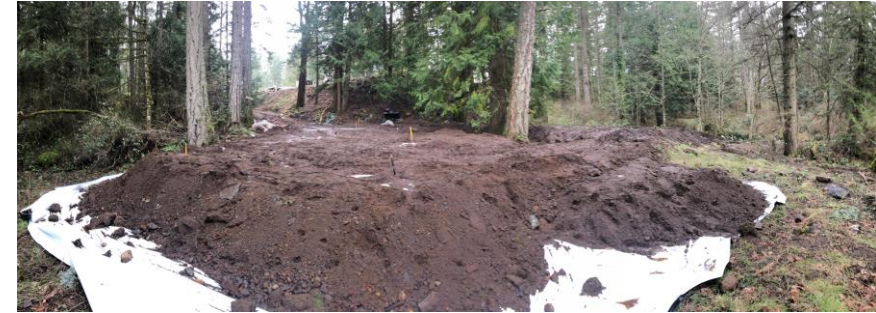
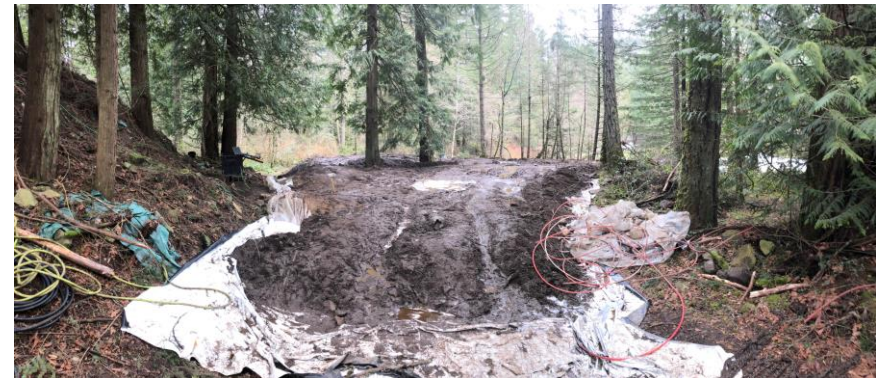
- This site was historically contaminated with heating oil which was stockpiled in 3 piles (Pile A, B, and C) which we moved to a single pile
- **Solution:**
 - The site was a project to be bioremediated using a combination of electrokinetics, and hydrocarbon degrading bacteria and fungi. **EKOGRID™** was used for delivery of remediation reagents and for remediation.
- **Results:**
 - The site has been treated for 30 days and a significant reduction in hydrocarbons occurred in the soil.

Parameter	Applicable Standard	Pile A Before	Pile B Before	Pile C Before	Post-1	Post-2	Post-3	Post-4	Post-5
C10-C19	1000 mg/kg	2520	901	4380	123	276	298	154	263
C19-C32	1000 mg/kg	1120	427	1670	167	303	307	258	306
