Case 12: Remote Sump Remediation

- This site was a remote sump located in northern British Columbia with hydrocarbon contamination.

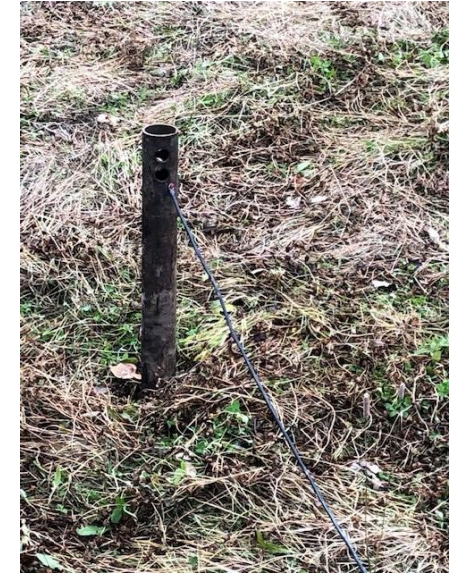
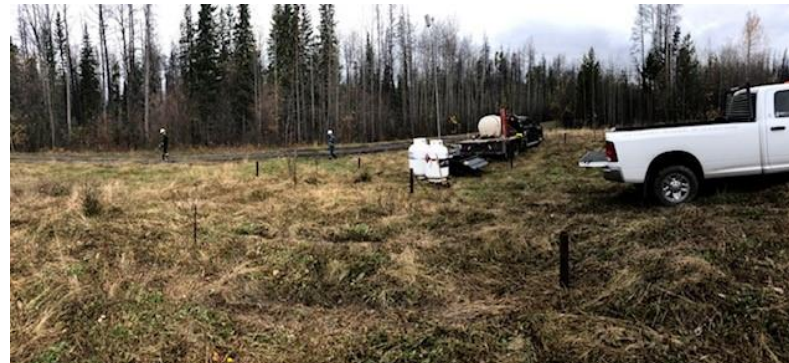
- **EKOGRID™** unit was setup on site with three rows of electrodes installed.
- This location had no utilities on site and a power supply was brought in to run the **EKOGRID™** for the duration of 25 Days.
- **Results:**
 - Reported in the diagram on the left
 - The numbers were dropped to the point where they would pass a screening-level risk assessment
 - Pre-remediation numbers were limited since the sump was found to contain H₂S and really limited the drilling program. It was not found to be sour post-remediation.

Parameter	Pre-Remediation	Post-Remediation
Benzene	1.45	0.361
Toluene	3.57	0.13
Ethylbenzene	0.22	0.129
Xylenes	2.41	0.53
C6-C10	<50	62
C10-C19	173	79
C19-C32	411	101
