Case 1: Dawson Creek, Canada

This location was an automotive repair operation in Dawson Creek, British Columbia. The fluid containment sump had historically failed and the soils below the building were impacted with lubricating oil. Remediation was completed without disturbing buried sanitary and natural gas pipelines in the area and the site remained operational throughout the process.

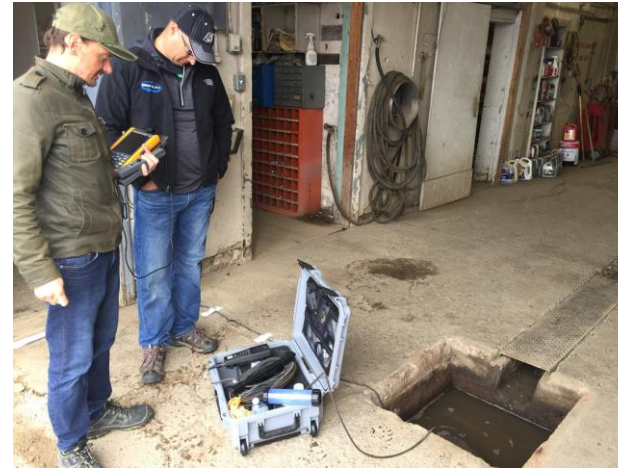
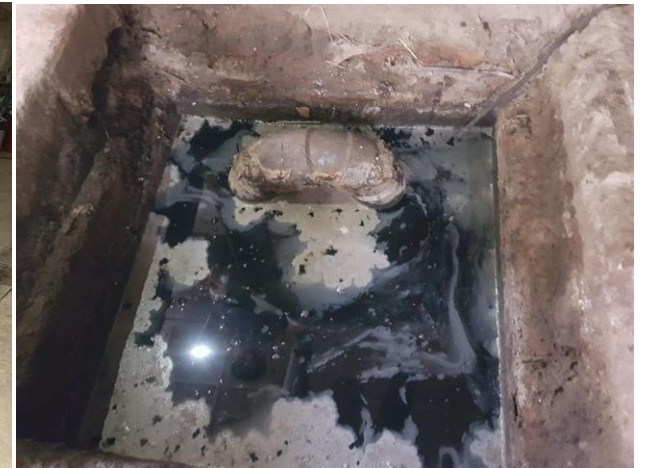
- In situ bioremediation was implemented using a combination of electrokinetics, biosurfactants, and hydrocarbon degrading bacteria and fungi. **EKOGRID™** was used for transport under the building at the site.
